Contract #: 04-0120F4Cty: SF/ALA Rte: 80 PM: 13.2/13.9File #: 1.28**WELDING INSPECTION REPORT****Resident Engineer:** Casey, William**Address:** 333 Burma Road**City:** Oakland, CA 94607**Report No:** WIR-026834**Date Inspected:** 07-Dec-2011**Project Name:** SAS Superstructure**OSM Arrival Time:** 700**Prime Contractor:** American Bridge/Fluor Enterprises, a JV**OSM Departure Time:** 1730**Contractor:** American Bridge/Fluor Enterprises, a JV**Location:** Job Site

Caltrans Office of Structural Material (OSM) Quality Assurance Inspector (QAI) Joselito Lizardo was present at the Self Anchored Suspension (SAS) job site as requested to perform observations on the welding of components for the San Francisco Oakland Bay Bridge (SFOBB) Project.

WELDING INSPECTION REPORT

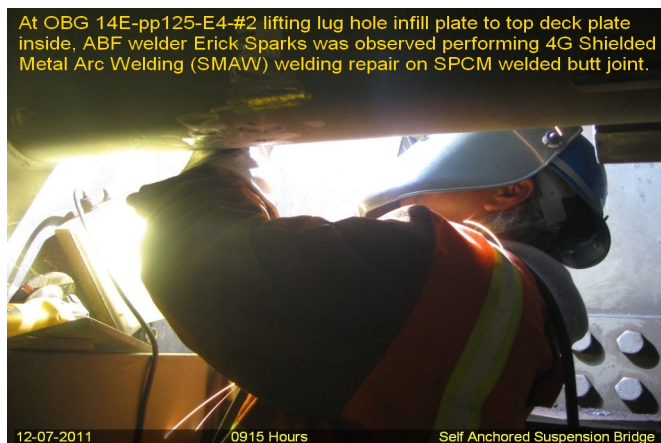
1. OBG 14E-PP126.7-E2.5 vent hole infill plate to deck plate outside - QA VT/MT verified
2. OBG 14W-PP126.2-W2.6 vent hole infill plate to deck plate outside - QA VT/MT verified
3. OBG 14W-PP126.2-W2.8 vent hole infill plate to deck plate outside - QA VT/MT verified
4. OBG 14W-PP126.7-W2.5 vent hole infill plate to deck plate outside - QA VT/MT verified
5. OBG 14E-PP127.2-W2 vent hole infill plate to deck plate outside - QA VT/MT verified
6. OBG 14E-PP127.2-W5 vent hole infill plate to deck plate outside - QA VT/MT verified
7. OBG 13E/14E side plate 'H' inside - QA VT/MT verified

At OBG 14E-PP125-E4- #2 lifting lug hole infill plate to top deck plate inside, QA randomly observed ABF/JV qualified welder Erick Sparks continuing to perform CJP groove welding repair. The welder was observed welding in the 4G (overhead) position utilizing Shielded Metal Arc Welding (SMAW) with 1/8" diameter E7018H4R electrode implementing welding procedure ABF-WPS-D15-1004-Repair for the Seismic Performance Critical Member (SPCM) butt joint. Prior the repair excavation, the weld butt joint and adjacent base metal were preheated to more than 225 degrees Fahrenheit using propane gas torch. After the excavation and subsequent smooth grinding, ABF QC Salvador Merino was observed performing Magnetic Particle Testing (MT) on the boat shape excavations with no significant defects noted during the test. The excavations and adjacent base metal were again preheated to more than 325 degrees Fahrenheit prior welding. ABF QC Salvador Merino was noted monitoring the welder at the time of the repair with measured working current of 130 amperes on a 1/8" diameter E7018H4R electrode. The welding repair located at Y-65 having dimensions of 50mm long x 18mm wide x 7mm deep was completely welded during the shift and was Post Weld Heat Treated (PWHT) at 450 degrees Fahrenheit for one (1) hour as required using the Miller Proheat 35 Induction Heating System.

At OBG 13E/14E top deck plate 'A2.2' outside, QA randomly observed ABF/JV qualified welder Jin Pei Wang perform CJP groove welding repair. The welder was observed welding in the 1G (flat) position utilizing Shielded Metal Arc Welding (SMAW) with 1/8" diameter E7018H4R electrode implementing welding procedure

At OBG 14E-PP127.2-E5 vent hole infill plate to top deck plate inside, ABF welder Erick Sparks was observed continuing to perform 1G Shielded Metal Arc Welding (SMAW) welding root pass on the infill plate to top deck plate butt joint. The welder was noted using 1/8" diameter E7018H4R implementing Welding Procedure Specification (WPS) ABF-WPS-D15-1050A-CU Rev.1 for the Seismic Performance Critical Member (SPCM) butt joint. Prior welding, ABF QC Salvador Merino was noted checking the fit up alignment of the infill plate to the deck plate with positive result. QA verified the alignment and noted same result. During welding, ABF QC Salvador Merino was noted monitoring the welder's welding parameters with measured working current of 130 amperes on the 1/8" diameter E7018H4R electrode. The welder was noted preheating the plates to more than 150°F using propylene gas torch prior welding. During the shift, fill pass welding was still continuing when the welder has to leave early due to his dental appointment.

At OBG 13E/14E side plate 'E' inside, QA randomly observed ABF/JV qualified welder Jin Pei Wang perform CJP groove (splice) welding root then on the splice butt joint. The welder was observed perform manual welding in the 3G (vertical) position utilizing a dual shield Flux Cored Arc Welding (FCAW-G) with E71T-1M, 1/16" diameter wire electrode and implementing Caltrans approved Welding Procedure Specification (WPS) ABF-WPS-D15-3042B-1. The joint being welded has a single V-groove butt joint with backing bar. The splice joint was preheated and maintained to greater than 150 degrees Fahrenheit using Miller Proheat 35 Induction Heating System heater blankets located at the opposite side of the plate prior/during welding. During welding, ABF Quality Control (QC) Fred Von Hoff was noted monitoring the welding parameters of the welder with measured working current of 270 amperes and working voltage of 25.2 volts. Prior welding, this QA verified the alignment where 5mm offset was noted previously. ABF personnel were noted working on it and it came down to 3mm. According to QC, this is the best ABF could do to make the correction but informed this QA that QC will map the unacceptable misalignment and submits it to ABF for further evaluation. At the end of the shift, welding of the root pass on the splice butt joint was still continuing and should remain tomorrow.
